# TORNADO RATING IN EUROPE WITH THE EF-SCALE

## *DEFINITION OF SPECIFIC DAMAGE INDICATORS FOR ACCURATE TORNADO RATINGS IN EUROPE*

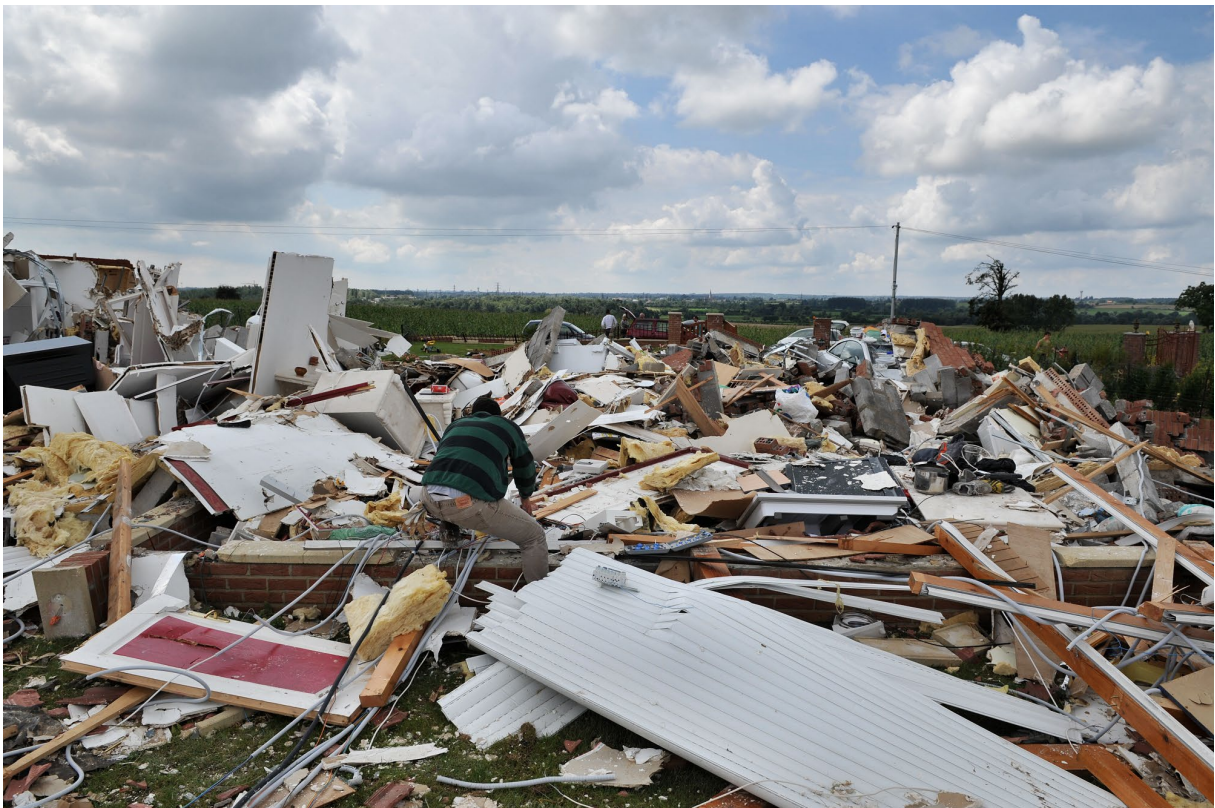
Damage caused by the Hautmont EF4 tornado of August 3, 2008 (France). © P. Mahieu, E. Wesolek

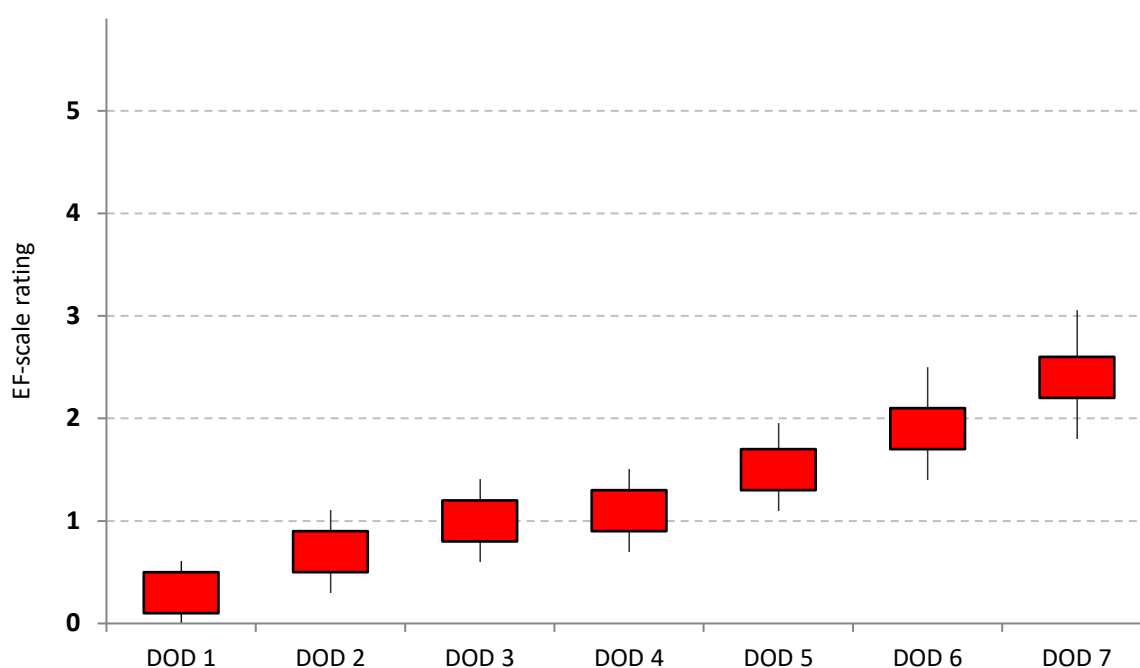
### POSITION OF DODS ON THE EF-SCALE

DOD	Damage description
1	first visible damage: guttering and occasional roofing elements torn down, roofing sheets bent,...
2	less than 50% of roofing damaged or torn off, no distance projections or very minor cases
3	doors pushed in or torn off hinges
4	more than 50% of roofing damaged or torn off; a few distance projections
5	roofing entirely torn off, walls or partitions partially collapsed
6	building almost entirely destroyed
7	building razed and blown away; building debris projected over a great distance

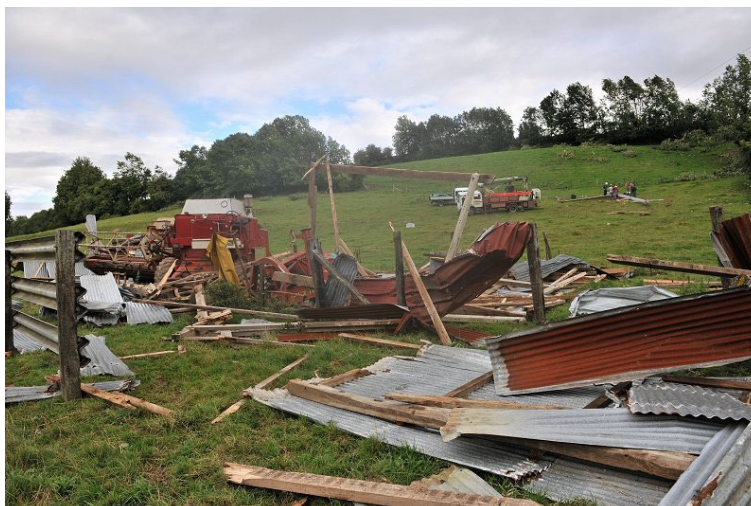
**E-1 DOD 7** : Humbert tornado of August 23, 2010 (France). Shed blown away, and debris projected over distance. © P. Mahieu, E. Wesolek / KERAUNOS.

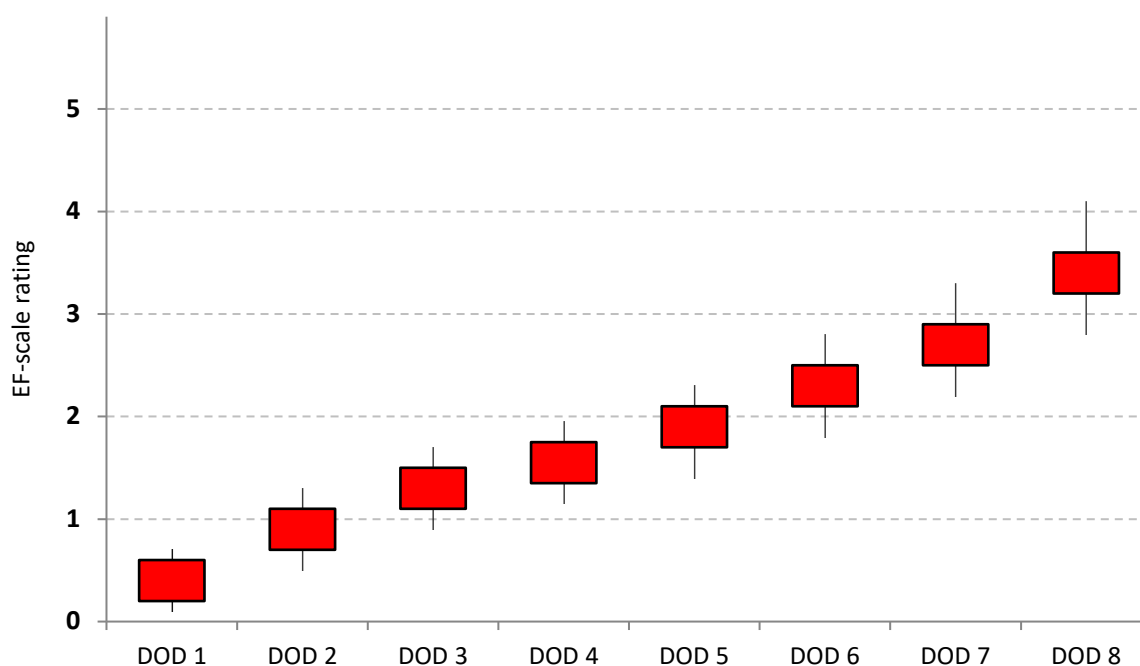
### POSITION OF DODS ON THE EF-SCALE

DOD	Damage description
1	first visible damage, superficial roof damage
2	between 10 and 50% of roofing damaged
3	more than 50% of roofing blown away
4	roofing totally blown away but roof structure intact
5	roofing torn off, roof structure damaged
6	roof blown away (roof structure blown away), walls damaged
7	housing partially destroyed, many walls collapsed
8	housing totally destroyed

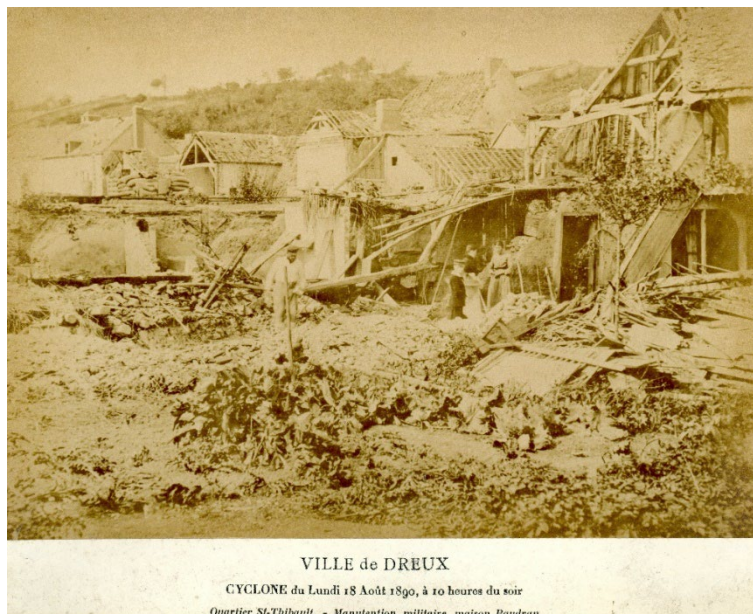
**E-2 DOD 8** : Dreux tornado of August 18, 1890 (France). House destroyed in the Saint-Thibault neighborhood. © Keraunos archives.

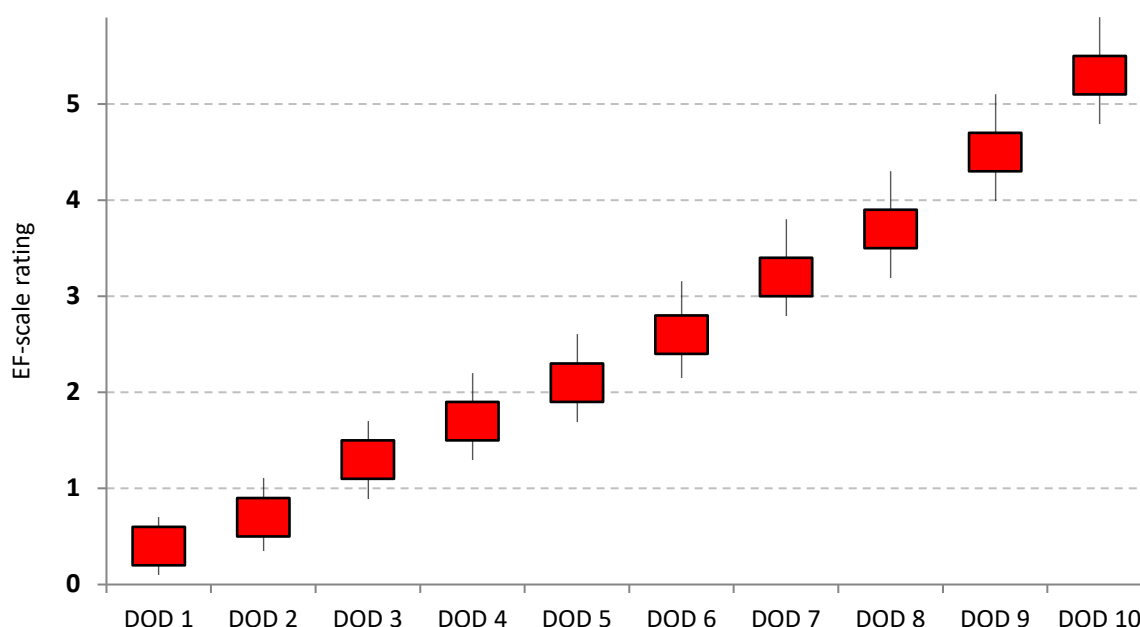
### POSITION OF DODS ON THE EF-SCALE

DOD	Damage description
1	first visible damage: some tiles moved, TV aerial twisted
2	roofing damaged (<20%), guttering and/or ridge tiles torn off
3	windows broken (windows or glazed doors), roofing partially torn off (20 to 50%),
4	more than 50% of roofing torn off, chimney stacks collapsed, garage doors bent inwards, ceilings raised, double-glazed patio doors sometimes smashed
5	roofing mostly torn off (>80%), large portions of roofing framework torn down, walls intact
6	roof entirely torn off and exterior walls damaged or collapsed
7	first floor partially or totally destroyed (interior or exterior walls destroyed), bungalows torn apart
8	exterior ground-floor walls demolished, only interior walls left standing
9	building totally destroyed
10	building razed and blown away, possible damage even at basement level

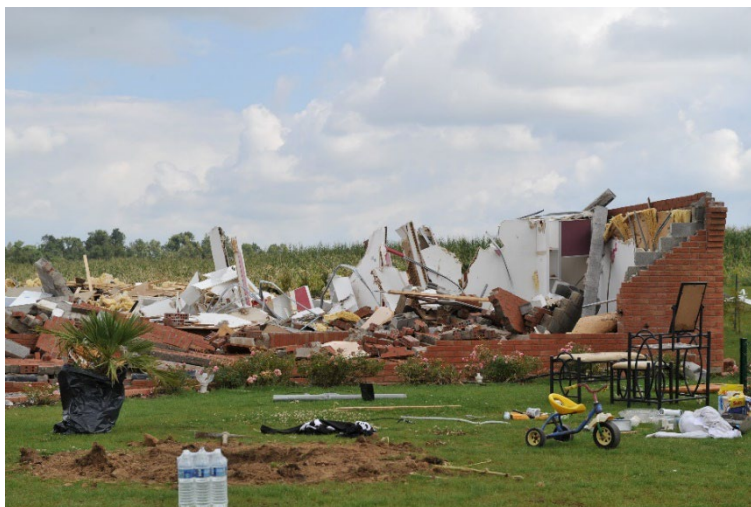
**E-3 DOD 9** : Hautmont tornado of August 3, 2008 (France). House almost totally destroyed in Boussières-sur-Sambre. © P. Mahieu, E. Wesolek / KERAUNOS.

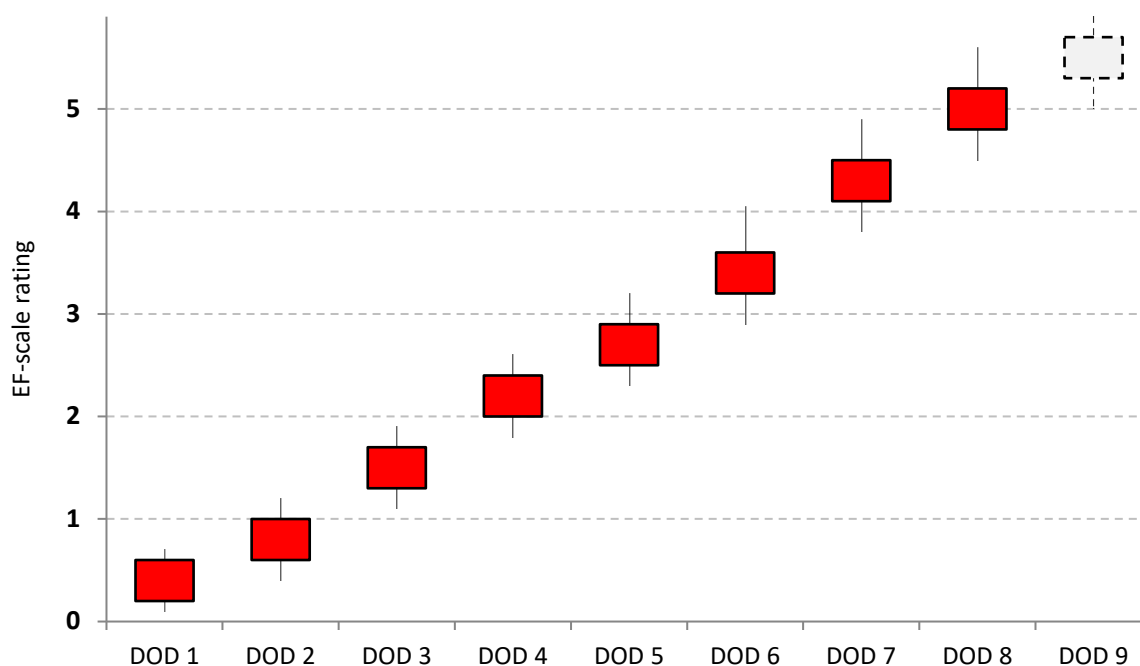
### POSITION OF DODS ON THE EF-SCALE

DOD	Damage description
1	first visible damage: TV aerials bent, ridge tiles damaged, guttering displaced, twisted or torn off, gables damaged
2	roofing slightly damaged (<20%)
3	roofing damaged (20 to 50%)
4	most of roofing torn off (> 50%), roofing framework damaged
5	roof entirely torn off or collapsed, upper floor walls damaged
6	house torn apart, upper floor destroyed, ground floor intact
7	most of building destroyed, ground floor walls partially collapsed
8	building entirely destroyed
9	building razed and blown away, possible damage even at basement level

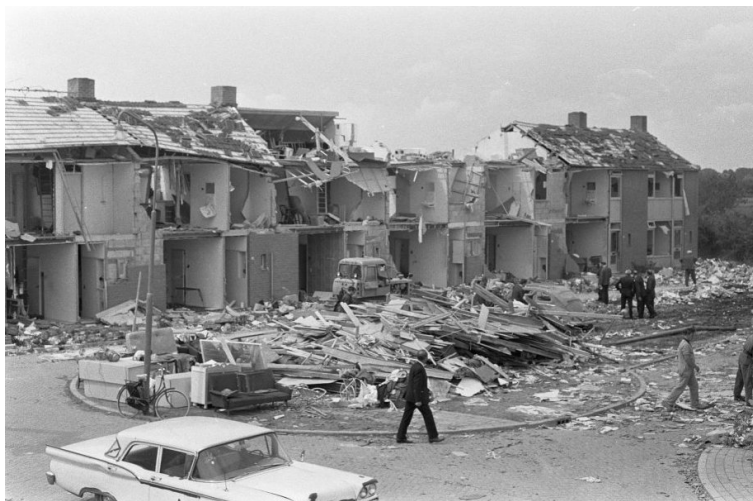
**E-4 DOD 6** : Tricht tornado of June 25, 1967 (Netherlands). Upper floor of a housing complex destroyed. © Dutch National Archives.

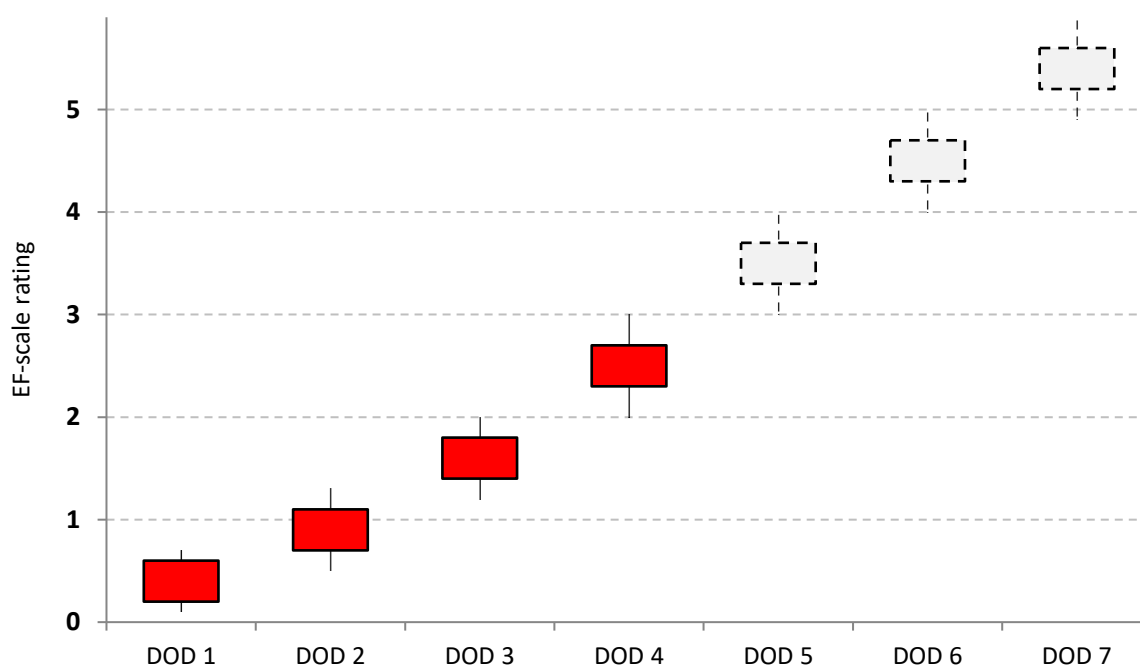
### POSITION OF DODS ON THE EF-SCALE

DOD	Damage description
1	first visible damage: ridge tiles damaged, guttering displaced, twisted or torn off, gables damaged
2	roofing elements bent or folded, some roofing elements torn away (<20%)
3	roofing torn off (20 to 50%), large chimney stacks and gables collapsed
4	more than 50% of roofing torn off, some framework torn away
5	roof torn off, upper floors partially collapsed, multiple damage to all upper floors
6	upper floor destroyed, structural damage to whole building
7	upper floors destroyed, significant structural damage to entire building

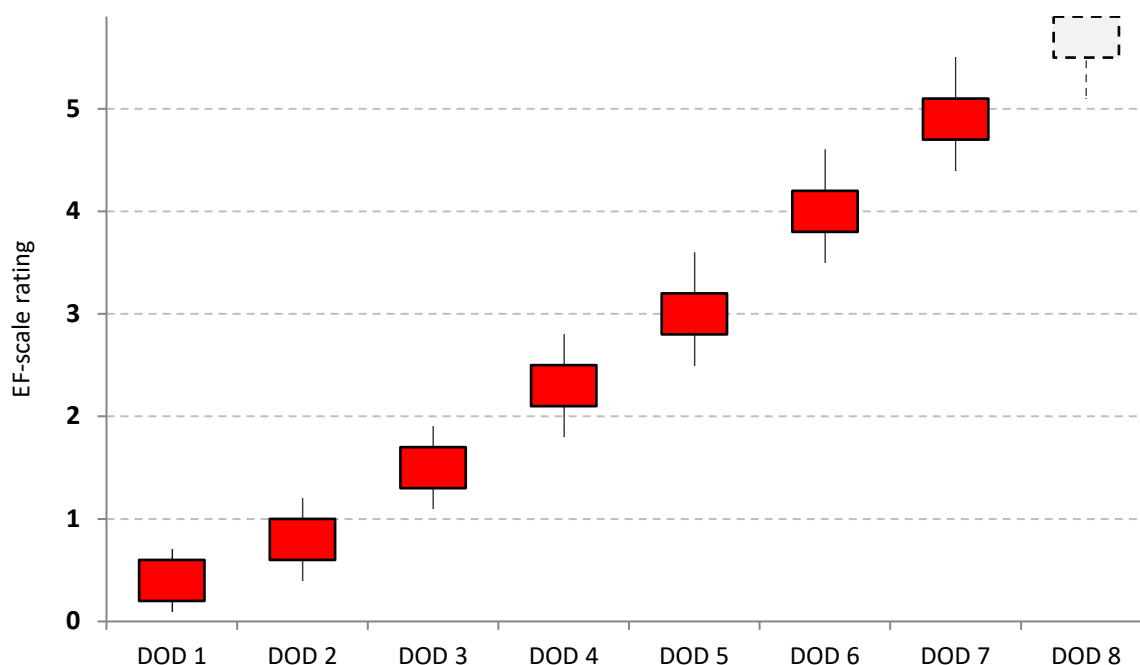
### POSITION OF DODS ON THE EF-SCALE

DOD	Damage description
1	superficial damage: ridge tiles damaged, guttering displaced, twisted or torn off
2	a few tiles moved (< 20% of the total roof)
3	20 to 50% of the roofing destroyed, roof framework intact
4	majority of roofing blown away (>50%) with some roof framework torn down, walls intact
5	roof entirely blown off, exterior walls partially damaged
6	many walls seriously damaged or collapsed
7	very few sections of walls remain standing
8	building entirely destroyed from the floors up

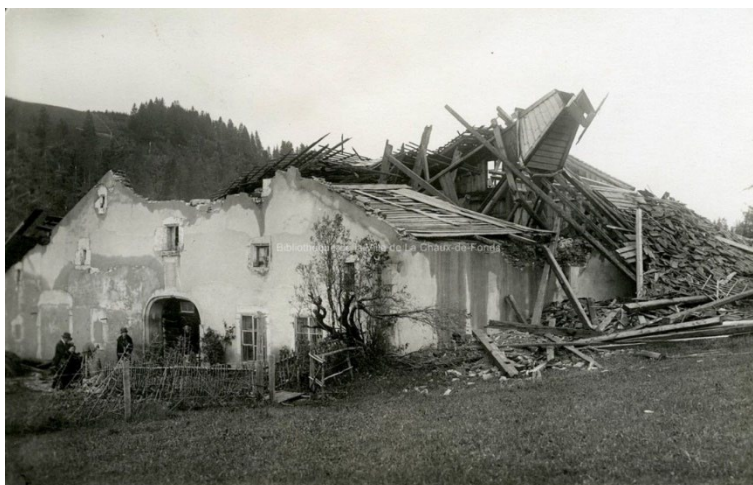
**E-6 DOD 5** : La Ferrière tornado of June 12, 1926 (Swiss). Roof of a farm completely torn off in La Chaux-de-Fonds; exterior walls partially damaged. © Library of La Chaux-de-Fonds.

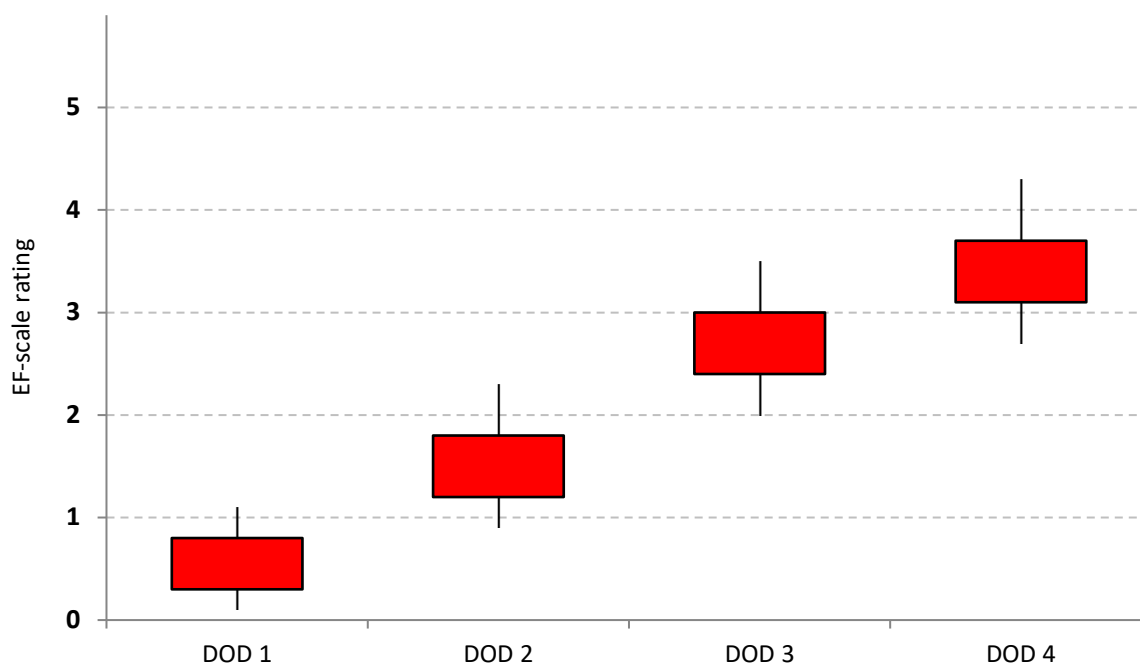
### POSITION OF DODS ON THE EF-SCALE

DOD	Damage description
1	superficial damage: some parts of roof blown off
2	dome or top section of fulcrum windmills blown off
3	structure partially destroyed, some timbers torn off and partial resistance of masonry-built sections
4	structure entirely destroyed

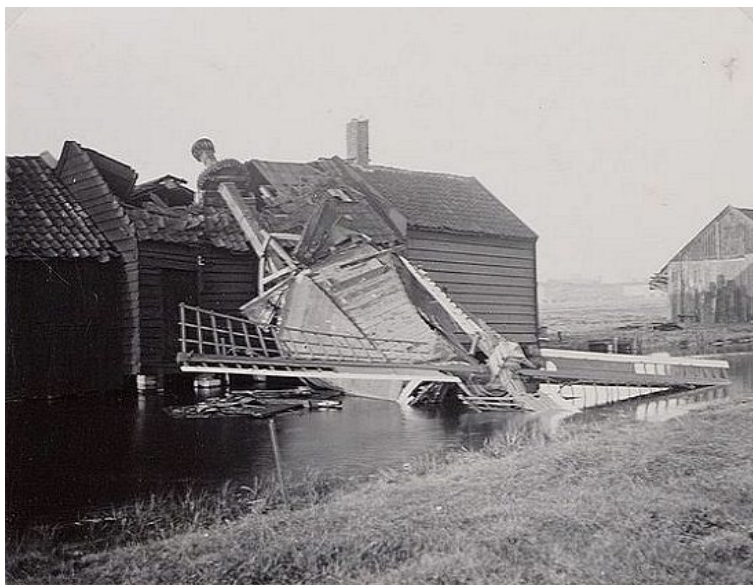
**E-7 DOD 2** : Zaandam tornado of August 21, 1930 (Netherlands). Dome of the windmill of Zaansche blown off. © Dutch National Archives.

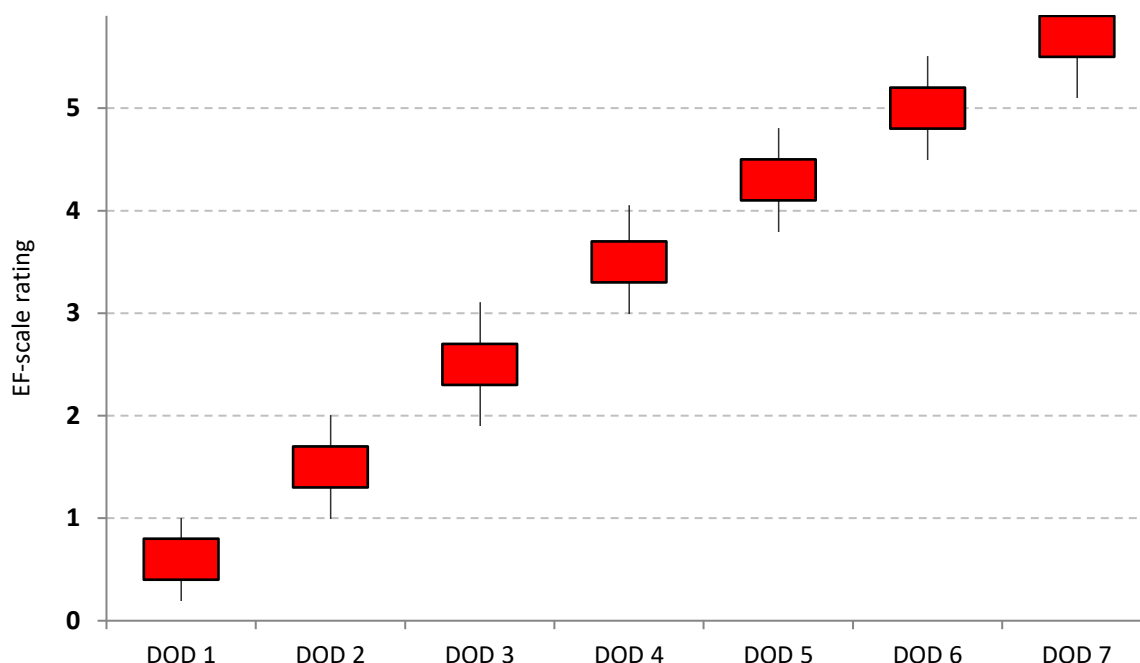
### POSITION OF DODS ON THE EF-SCALE

DOD	Damage description
1	superficial damage: some roofing elements torn off (gutters, embellishments)
2	light damage to roofing or upper floors: roofing and waterproofing elements torn off, windows broken; small portions of roofing torn off (< 20%); chimneys collapsed
3	significant portion of roofing torn down (20 to 50%); chimneys collapsed or mostly destroyed
4	more than 50% of roof torn down, with partial destruction of upper floors (ceilings, walls of upper floors)
5	roofing totally torn off, many walls collapsed on upper floors, building torn apart
6	building largely destroyed, many walls collapsed on lower floors
7	building entirely destroyed

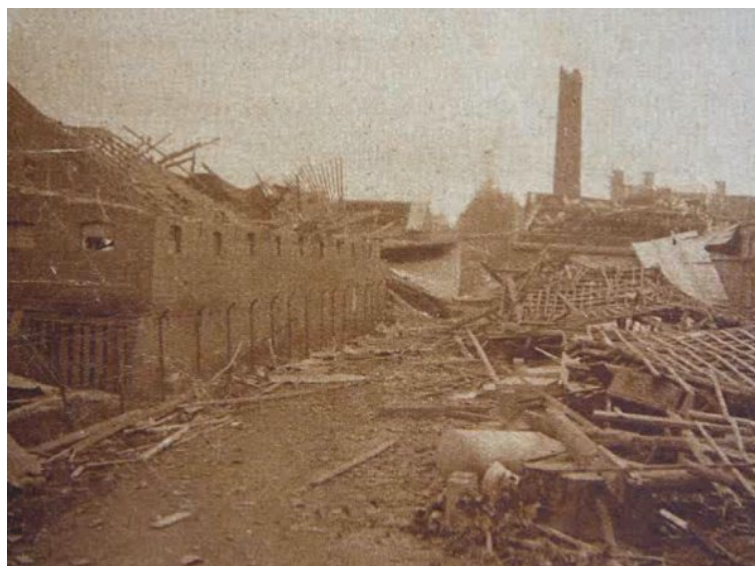
**E-8 DOD 5** : Neede tornado of June 1st, 1927 (Netherlands). One of the main buildings of the Ter Weeme & Fils factory torn apart. © Dutch National Archives.

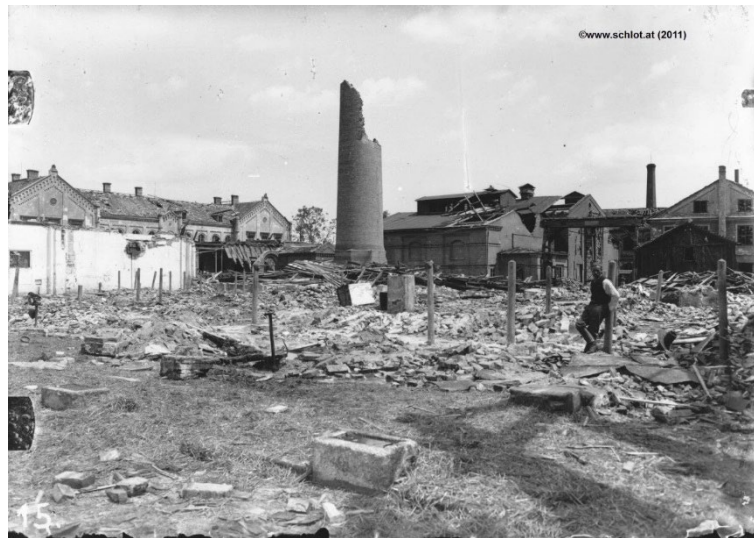
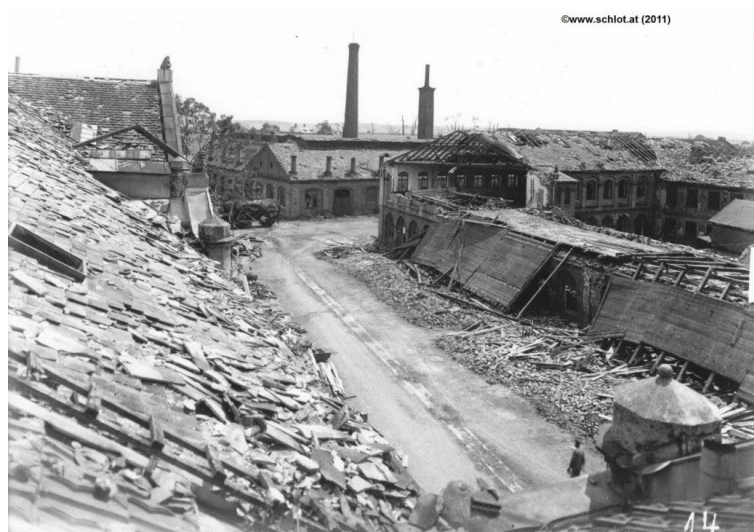
**E-8 DOD 5 :** Wiener Neustadt tornado of July 10, 1916 (Austria). Building of a locomotive factory torn apart. © [www.schlot.at](http://www.schlot.at).

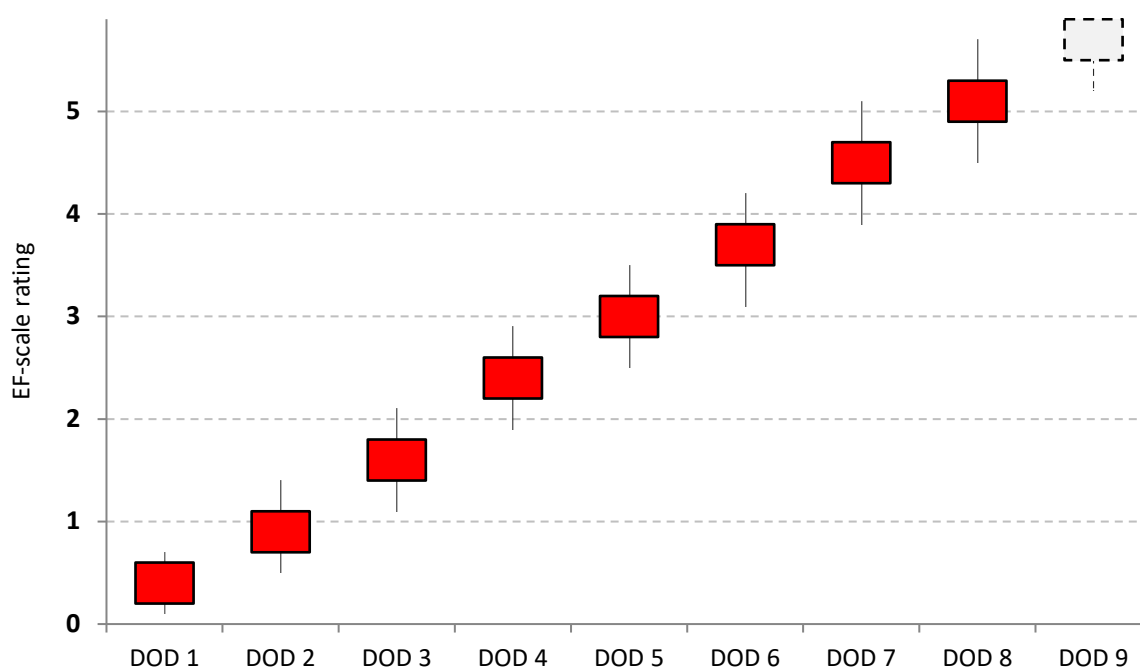
### POSITION OF DODS ON THE EF-SCALE

DOD	Damage description
1	first visible damage: decorative elements damaged
2	limited portions of roofing torn off (<20%)
3	significant loss of roofing (20-50%); slight damage to top of bell tower; some decorative elements in dressed stone broken or torn down (cross, gables, statues)
4	church spire toppled
5	major sections of roof torn off (50-80%), framework damaged; walls intact
6	more than 80% of roof torn off and carried over some distance; some walls collapsed; damage to bell tower structure
7	roof entirely torn off; many walls collapsed; bell tower partially destroyed
8	most of bell tower destroyed, most walls collapsed
9	total destruction of edifice

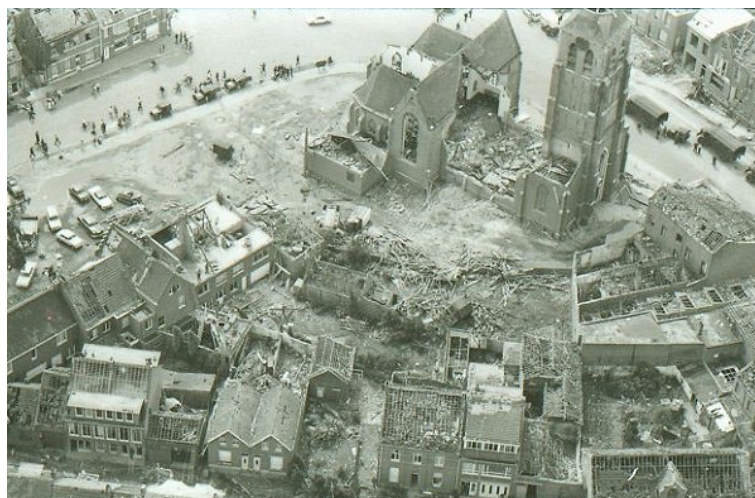
**E-9 DOD 6** : Oostmalle tornado of June 25, 1967 (Malle, Belgium). Church of Oostmalle torn apart. © Heemkundige Kring van Malle, RTL Nieuws.

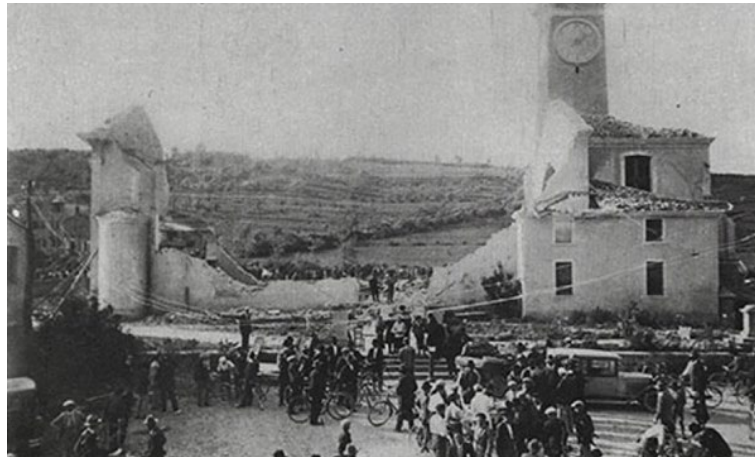
**E-9 DOD 8:** Montello tornado of July 24, 1930 (Italy). Church of Selva del Montello almost completely destroyed. © Keraunos archives.

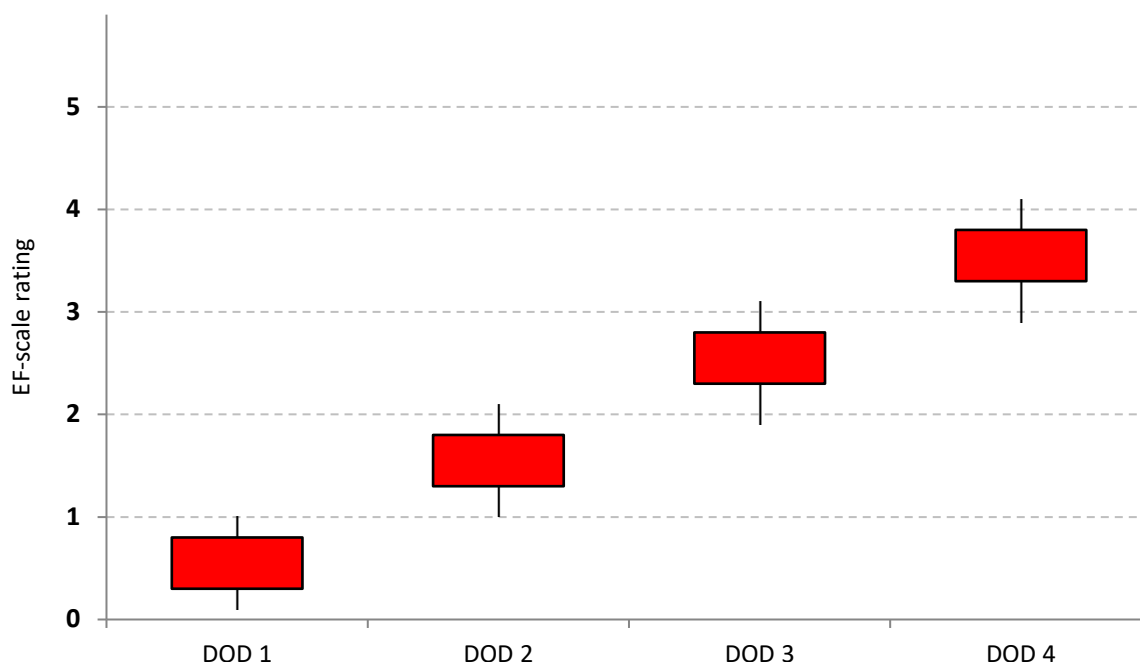
### POSITION OF DODS ON THE EF-SCALE

DOD	Damage description
1	minor roofing damage: less than 20% of roofing damaged
2	between 20 and 50% of roofing damaged, falling stonework and broken windows, building structure intact
3	roofing heavily damaged (> 50%), some damage to framework, possible structural damage to upper levels
4	upper levels damaged: ceilings and dividing walls collapsed, walls cracked, roofs entirely torn off

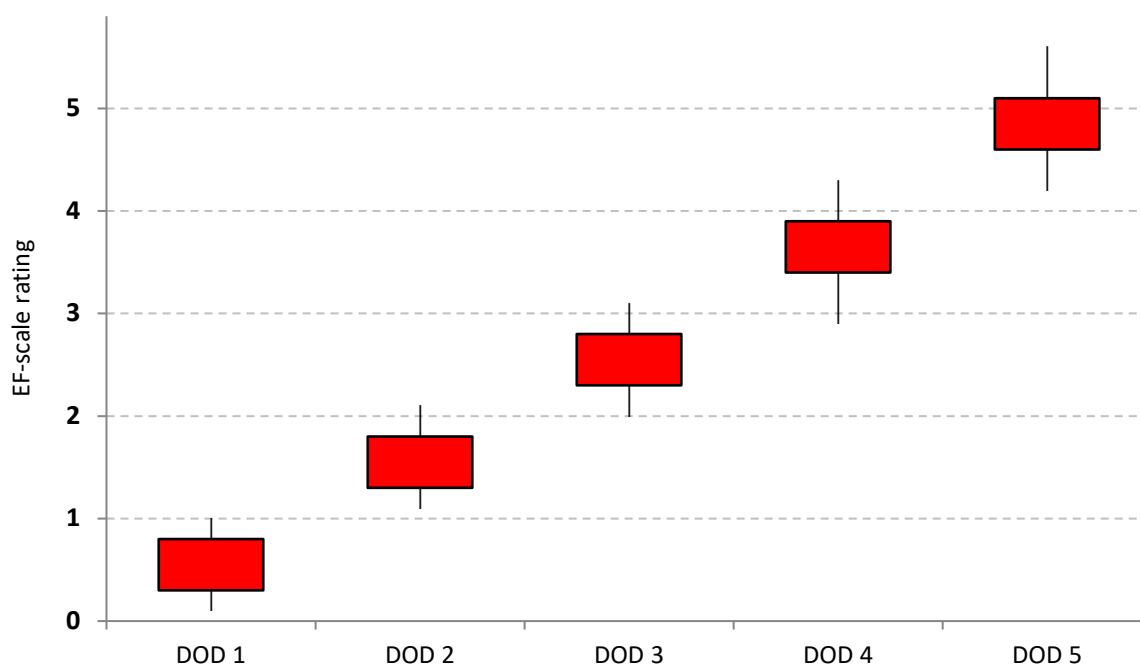
### POSITION OF DODS ON THE EF-SCALE

DOD	Damage description
1	minor damage, some roofing elements torn down (< 20%), decorative elements sometimes destroyed or torn down
2	roof damaged (20 to 50%) but framework intact, chimneys collapsed, windows broken, numerous decorative elements and gables damaged
3	roof largely torn off (> 50%), roof timbers damaged, some exterior walls cracked
4	roof torn off, exterior walls cracked, upper floors damaged or torn apart
5	building largely destroyed, some sections of wall remain standing on ground floor

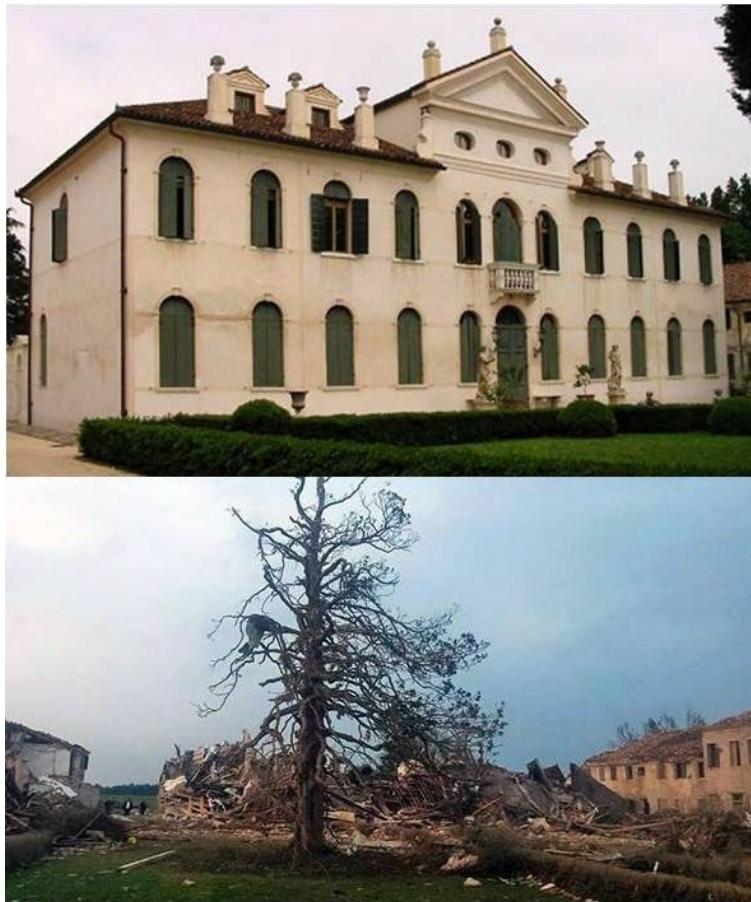
**E-11** without damage (**DOD 0**) and **E-11 DOD 5** : Mira tornado of July 8, 2015 (Italy). Almost total destruction of the Villa Fini (17<sup>th</sup> century) in Dolo.

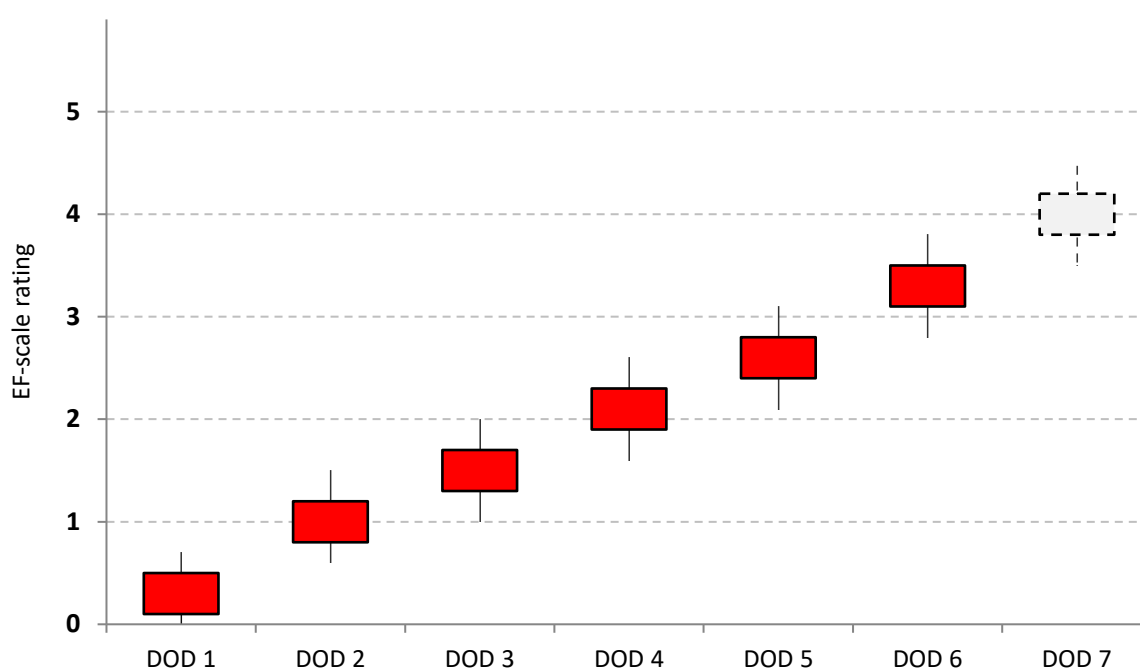
### POSITION OF DODS ON THE EF-SCALE

DOD	Damage description
1	first visible damage: some pieces of cladding torn off
2	roof covering blown off (<20%)
3	significant losses to roofing elements (20 to 50%), store windows often broken
4	most of the roof structure torn off (> 50%)
5	roof entirely torn apart and part of walls collapsed
6	building largely destroyed, many walls collapsed
7	building entirely destroyed

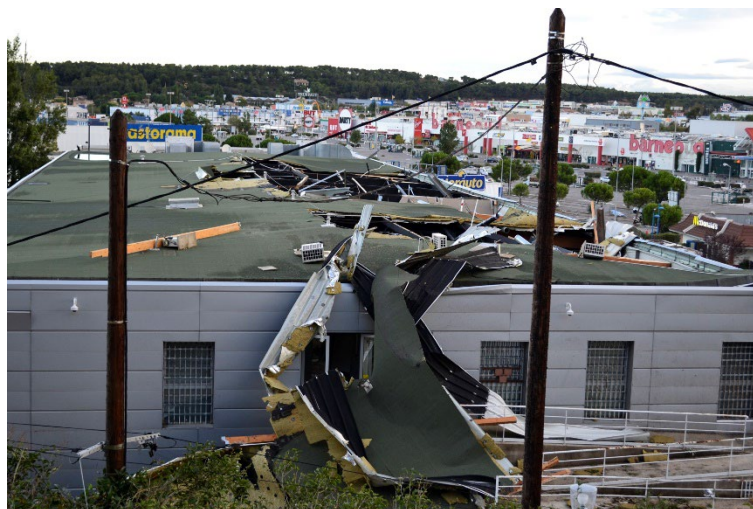
**E-12 DOD 3** : Les Pennes-Mirabeau tornado of October 14, 2012 (France). Significant losses to roofing elements. © D. Dumas / KERAUNOS.

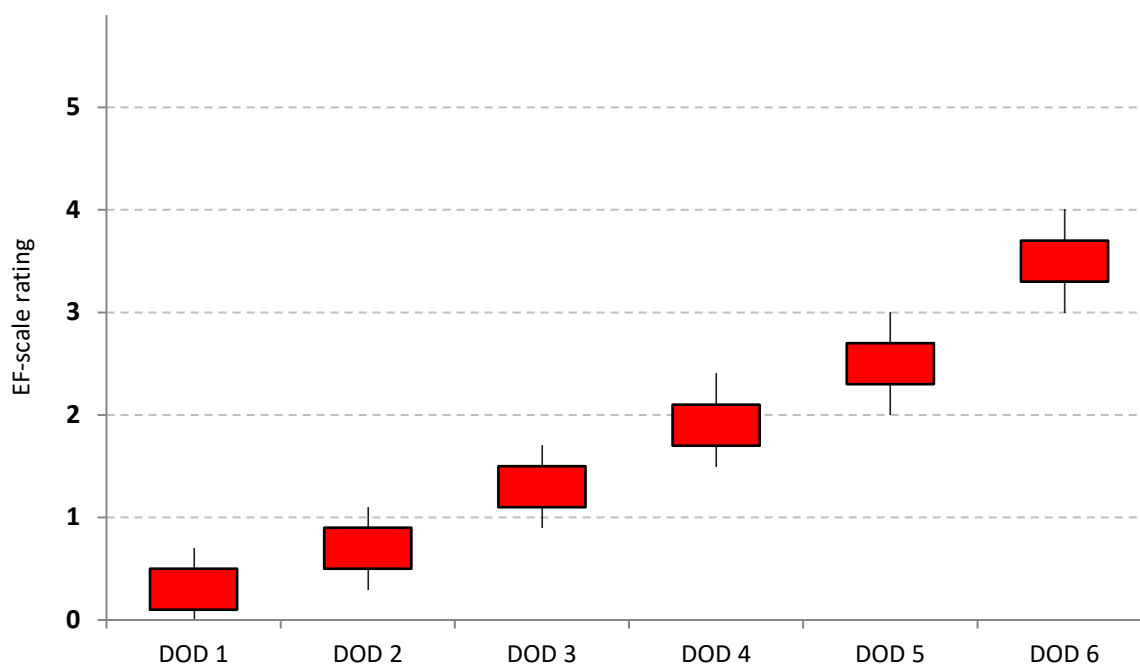
### POSITION OF DODS ON THE EF-SCALE

DOD	Damage description
1	first visible damage (small debris hanging from cables)
2	low voltage transmission poles (wooden) broken, electrical cables grounded
3	timber electricity poles leaning or levelled
4	timber electricity poles snapped
5	metal or concrete electricity poles leaning or twisted
6	high voltage pylons toppled; concrete pylons snapped

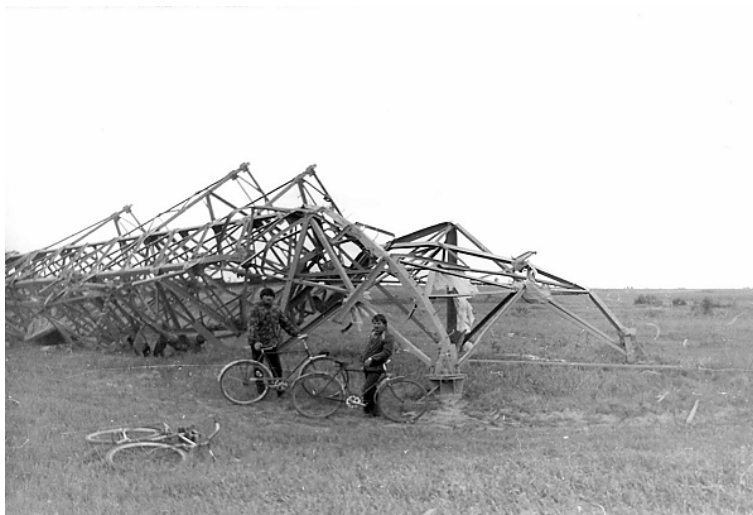
**E-13 DOD 6** : Ivanovo tornado of June 6, 1984 (Russia). High voltage pylons toppled.

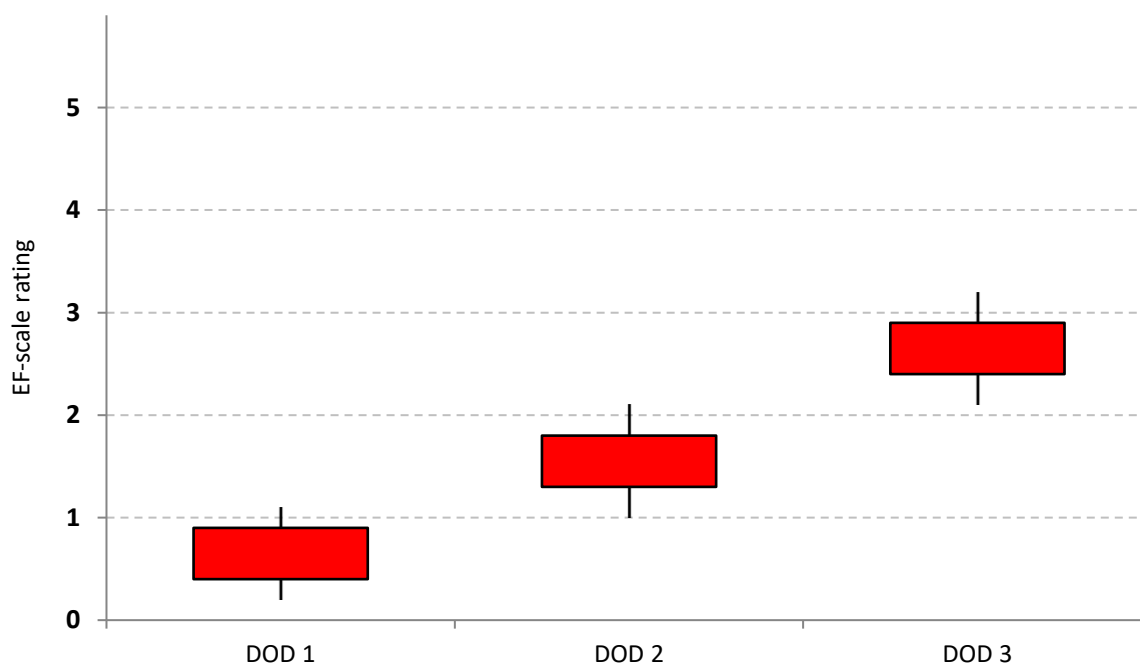
### POSITION OF DODS ON THE EF-SCALE

DOD	Damage description
1	first visible damage: light damaged or broken
2	street lamp or lamppost leaned over
3	street lamp or lamppost twisted, broken or ripped out

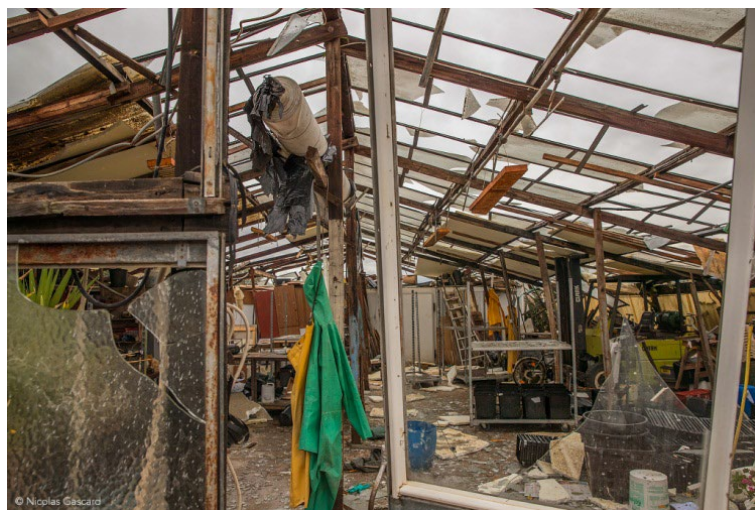
**E-15 DOD 2**: Hyères tornado of November 5, 2017 (France). Damaged greenhouse, with covering mostly destroyed. © N. Gascard

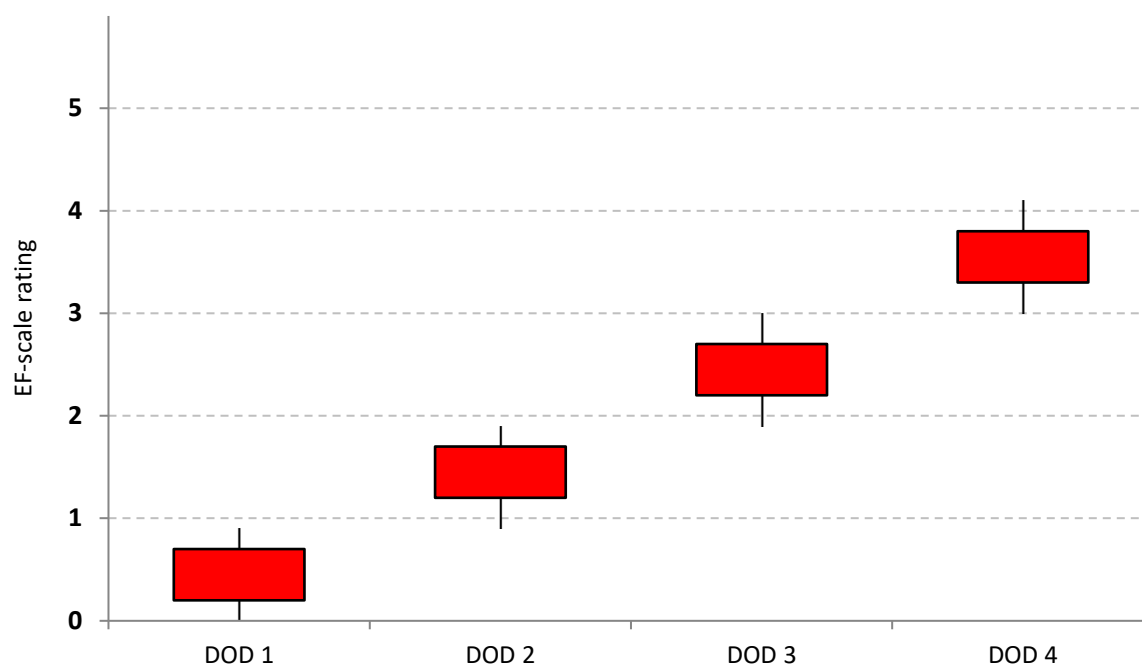
### POSITION OF DODS ON THE EF-SCALE

DOD	Damage description
1	vines stripped and grapes torn off vines
2	overall damage to vine stocks; stakes blown over or sometimes carried off; some vines leaning or levelled
3	many vines blow over; stakes carried some distance away
4	vines broken, stocks torn out and carried away

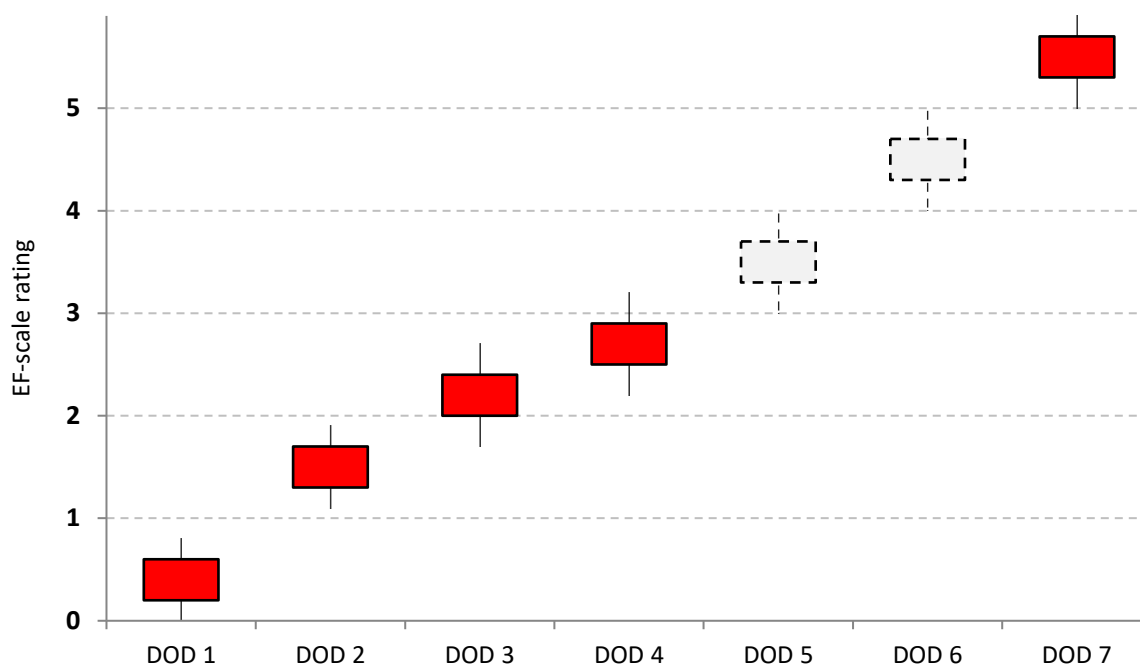
### POSITION OF DODS ON THE EF-SCALE

DOD	Damage description
1	no visible damage to graves; funerary decorations blown away
2	crosses or funerary monuments leaning or levelled
3	crosses or funerary monuments moved/or broken
4	some tombstones lifted from the ground, graves uncovered, bodies exhumed
5	tombstones lifted from the ground and carried over some distance (up to 50 to 100 metres)
6	tombstones lifted from the ground and carried over long distances (100 to 200 metres)
7	tombstones lifted from the ground and carried over very long distances (more than 200 metres)

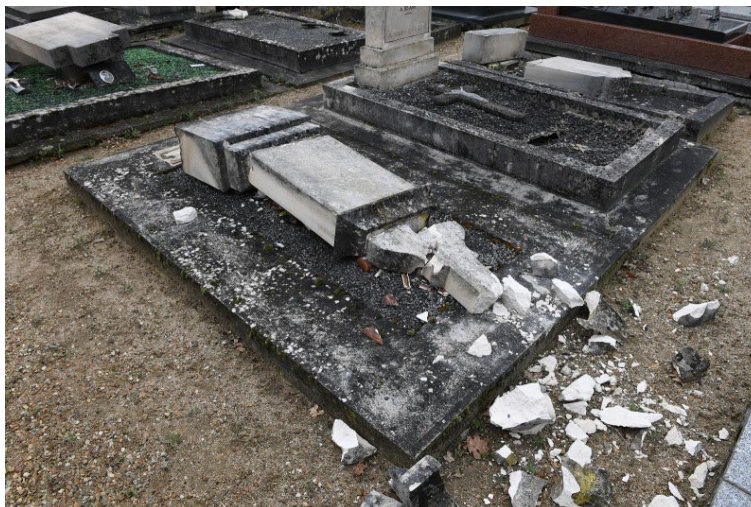
**E-18 DOD 2** : Lorris tornado of March 5, 2017 (France). Steles leveled. © P. Mahieu, E. Wesolek / KERAUNOS.
