# TORNADO RATING IN EUROPE WITH THE EF-SCALE

## *DEFINITION OF SPECIFIC DAMAGE INDICATORS FOR ACCURATE TORNADO RATINGS IN EUROPE*

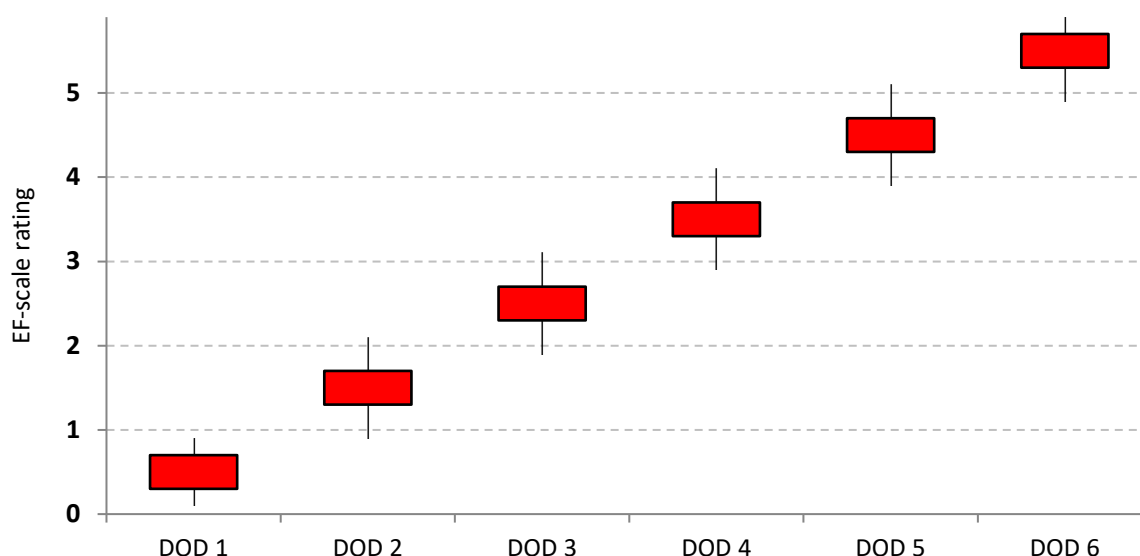
### POSITION OF DODS ON THE EF-SCALE

DOD	Damage description
1	vehicles sometimes shaken, but no direct damage; slight movement possible
2	cars and vans slightly moved; windows broken; trucks, articulated trucks, buses and other larger vehicles toppled
3	cars often moved, sometimes toppled or overturned; vans toppled or carried over short distance; agricultural vehicles (several tonnes) moved; articulated trucks sometimes lifted from the ground and carried over short distances
4	cars and vans moved or overturned; some vehicles rolled across the ground or even lifted from the ground and carried over distances (generally less than 100 metres); trucks, articulated trucks and other larger vehicles sometimes carried over longer distances
5	cars and vans lifted up and carried over large distances (usually 100 to 200 metres); trucks, articulated trucks and other larger vehicles sometimes carried over even longer distances
6	all vehicles moved and lifted up, often turning into missiles and thrown very large distances, generally over 200 metres, sometimes over 500 metres; trucks, articulated trucks and other larger vehicles sometimes carried over considerable distances (over 1 km)

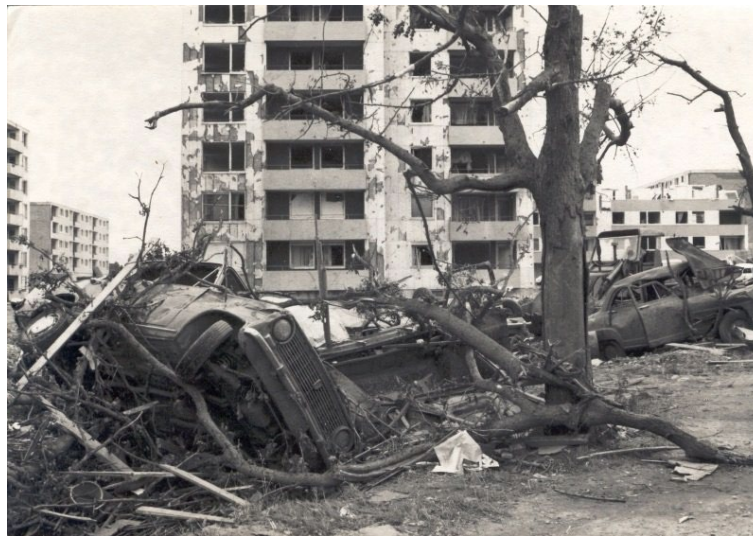
**E-19 DOD 5 :** Pforzheim tornado of July 10, 1968 (Germany). Cars lifted up and carried over large distances. © Peter Zeller.

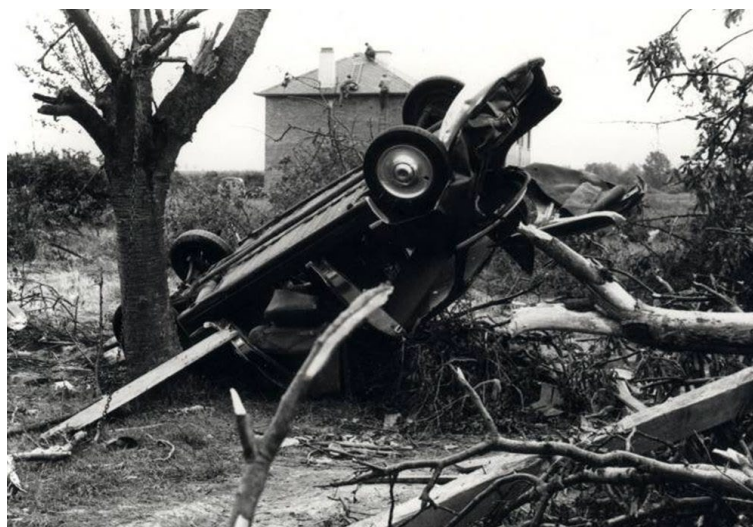
**E-19 DOD 5 :** Palluel tornado of June 24, 1967 (France). Car lifted up and carried over 60 meters. © Jean Dessens.

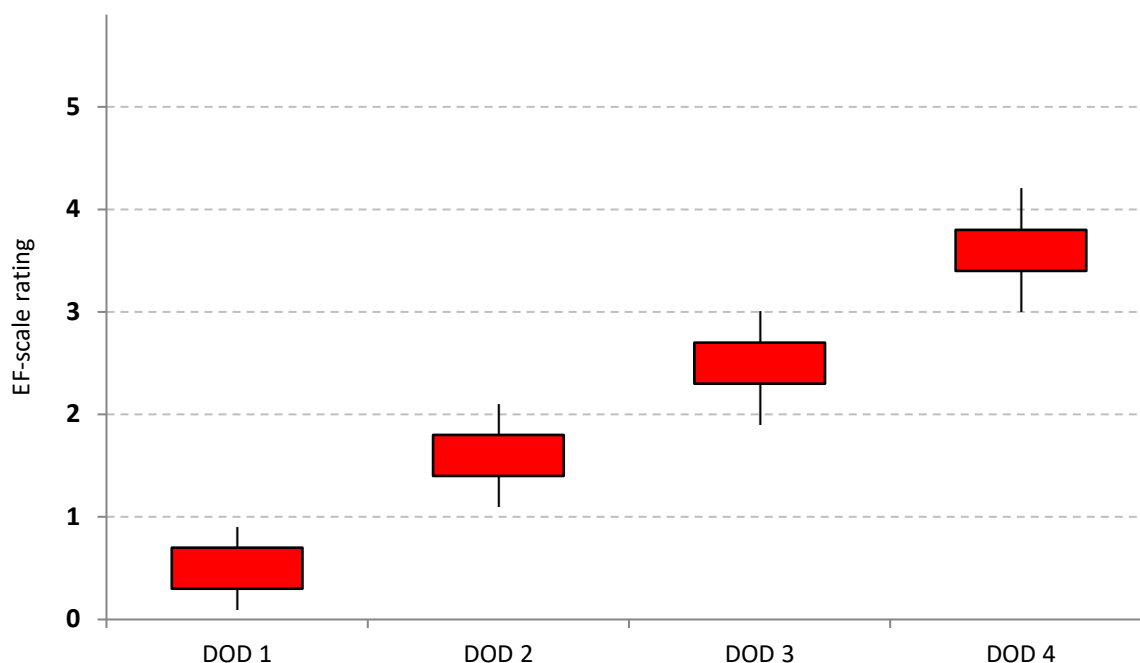
### POSITION OF DODS ON THE EF-SCALE

DOD	Damage description
1	empty caravans sometimes moved; windows broken or portholes loosened in certain cases
2	empty caravans pulled along the ground, toppled, overturned, even lifted up slightly; loaded caravans moved and sometimes toppled
3	empty caravans sometimes carried over some distance and sometimes destroyed; loaded caravans pulled along and overturned
4	all caravans, empty or loaded, lifted up, carried over distance and smashed

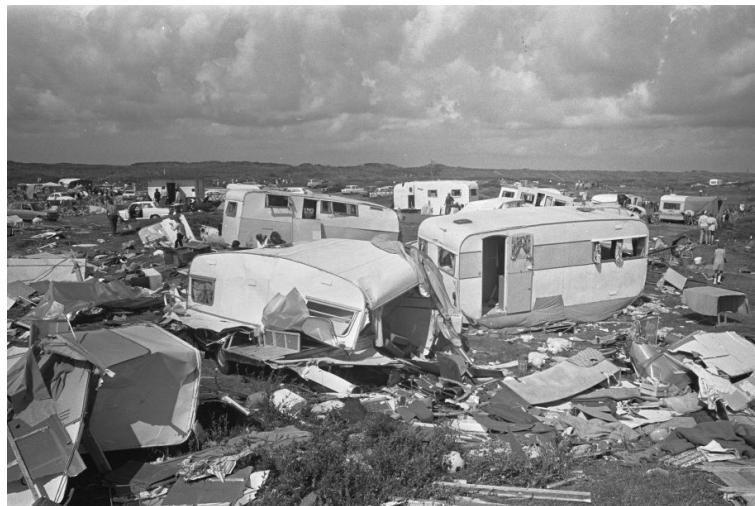
**E-20 DOD 3** : Ameland tornado of August 11, 1972 (Netherlands). Loaded caravans pulled along and overturned in a campsite. © Dutch National Archives.
